TEST REPORT

Reduction of Bird – Window Strikes

SEEN glass elements

Tests in Flight Tunnel II
according to WIN-tests
at Biologische Station Hohenau-Ringelsdorf,
Austria

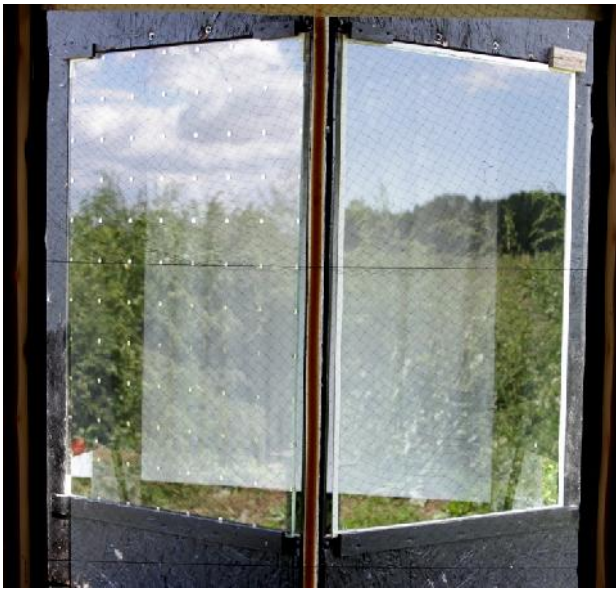
Figure 1: Test candidate “SEEN shiny” (left) and unmarked float glass reference (right) in the perspective of an approaching bird in the flight tunnel.

Tab. 1 shows characteristics, reference pane used in the choice experiment, test period and test sample sizes of the two prototypes with reflective dots (“SEEN shiny”, Fig. 1) and semi-reflective dots (“SEEN matt”, Fig. 2).

Reflective dots – “SEEN shiny”

Glass composition: 4mm low iron glass + 2 x 0.76mm PVB interlayer + 4mm low iron glass, SEEN glass elements applied on inner PVB.

Pattern: 9mm dots with a distance of 90mm from point center to point center, covered area 0,8%.

Material: dots (SEEN glass elements) are multi-layer elements with reflective aluminium coating on the front, colored black on the rear side (rear side can also be the same as front side). Due to the composition of the layers, they are having a 3D effect. The visual reflection of the reflective aluminium coating is 89% (measured in the laminated glass).

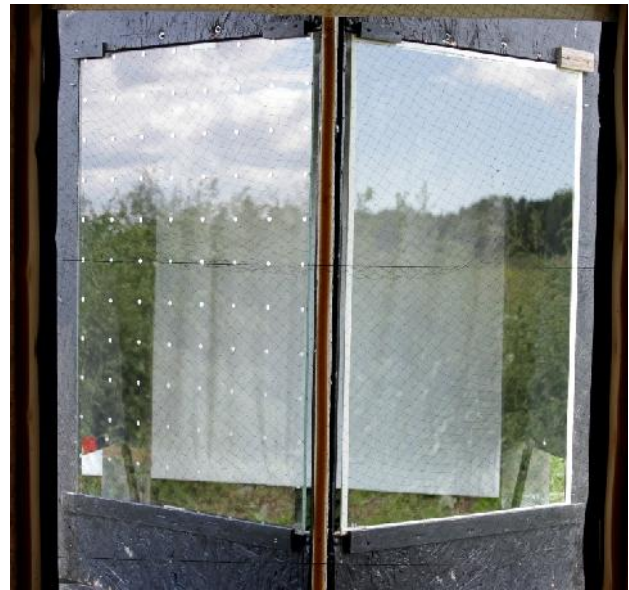
Figure 2: Test candidate “SEEN matt” to the left, float glass reference to the right.

Semi-reflective dots – “SEEN matt”

Glass composition: 4mm low iron glass + 2 x 0.76mm PVB interlayer + 4mm low iron glass, SEEN glass elements applied on inner PVB.

Pattern: 9mm dots with a distance of 90mm from point center to point center, covered area 0,8 %.

Material: Same material as reflective dots, but the visual reflection of the semi-reflective aluminium coating is 75% (measured in the laminated glass).
